Passage Through a Small Drainage Culvert by Mule Deer, *Odocoileus hemionus*, and Other Mammals

Krawchuk, Alissa, Karl W. Larsen, Richard D. Weir, and Helen Davis. 2005. Passage through a small drainage culvert by Mule Deer, *Odocoileus hemionus*, and other mammals. *Canadian Field-Naturalist* 119(2): 296-298.

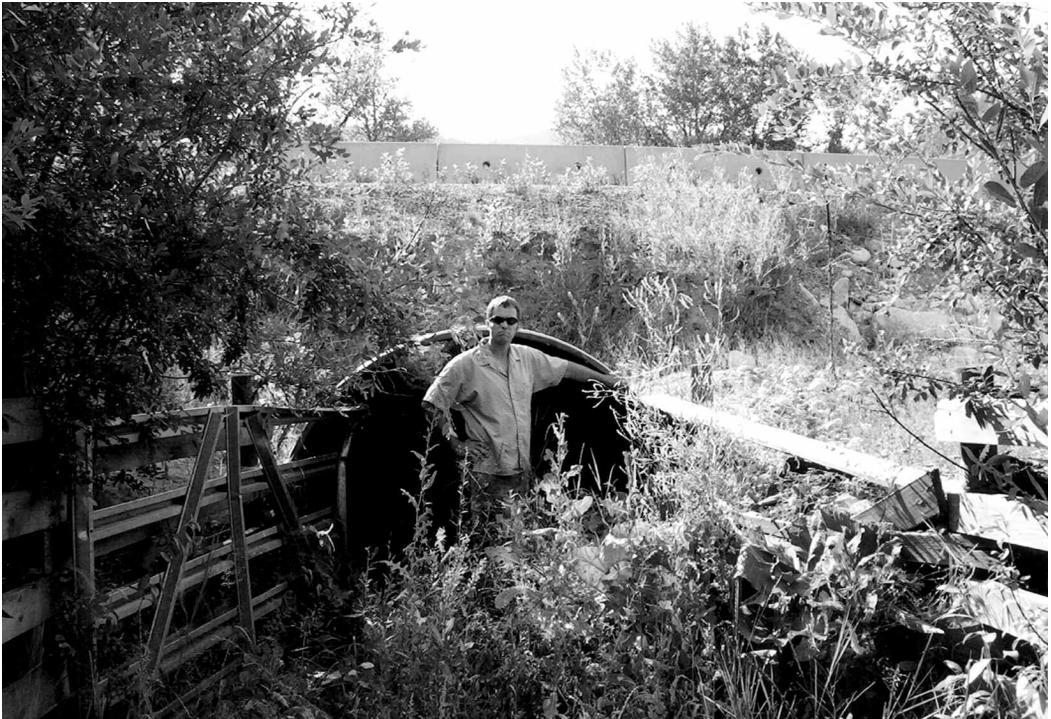
FIGURE 1. Drainage culvert at Site 1, used repeatedly by Mule Deer to travel under the Trans-Canada Highway near Kamloops, British Columbia (dimensions of culvert: 2.1 m wide, 1.5 m tall, 30 m long).

This study took place in the fall of 2003. We chose three crossing structures (two drainage culverts and one cattle underpass) east of Kamloops, British Columbia (119°52'W, 50°39'N) to monitor with infra-red sensor cameras. Each of these three crossings extends under both the Trans-Canada Highway and the Canadian Pacific Railway. The former is the major transportation corridor for motorists traveling through the Kamloops region. Monthly average daily traffic on this road for September to November ranges between 10 000 and 15 000 vehicles per day (British Columbia Ministry of Transportation, Transportation Information Management System data [1997-1999]). At two of the three sites we monitored (Site 1 and 2), the highway consisted of four lanes for at least 1 km in either direction. The dimensions of the crossing structures at the three sites are summarized in Table 1 (see Figure 1).

Mule Deer were detected traveling through the Site 1 culvert that had an openness ratio of only 0.11 (Table 1). The camera at this site recorded Mule Deer on six different occasions over the 10-week study. This culvert had a dirt substrate, was surrounded on either side by vegetation, and was relatively far from human activity. Deer were not detected at Site 2, however, a road-killed deer was found within 50 m of the culvert during the study period, suggesting deer were in the vicinity. Deer also were not detected at Site 3, possibly due in part to the faulty flash (see above), but deer tracks were seen in the area of the underpass during the study period.
